NEW YORK GATEWAY CONNECTIONS
IMPROVEMENT PROJECT TO THE US PEACE BRIDGE PLAZA

ATTACHMENT A

VIA WORKSHEETS

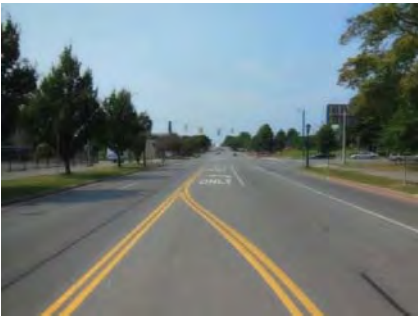
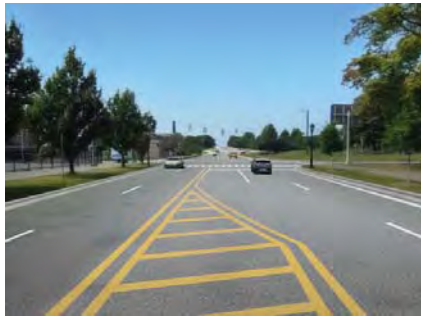
Visual Impact Assessment Worksheet						
Project:	New York Gateway Connections Improvement Project to the US Peace Bridge Plaza				Alternative:	Proposed Action
Location:	Porter Avenue Looking Southwest (Roundabout Option)			Key View No.	1a	
Photos	Existing			Proposed

Viewer Group:	Local Residents / Travelers / Commuters / Recreational Users		Landscape Unit:	Commercial / Institutional	
	Existing		Proposed		Change	
VIVIDNESS	<p>The foreground and middleground views are dominated by Porter Avenue, roadside landscaping, and commercial buildings are typical and unmemorable. The background view of Lake Erie is obstructed by the rising Porter Avenue that crosses the I-190. The vividness rating is low.</p>		<p>The foreground and middleground views are dominated by Porter Avenue, roadside landscaping, and commercial buildings are typical and unmemorable. The background view of Lake Erie remains obstructed by the roundabout and rising Porter Avenue that crosses the I-190. The introduction of the roundabout provides a focal point in the background. The vividness rating is low.</p>		<p>Vividness rating would increase.</p>

VIVIDNESS RATING:	1.5	VIVIDNESS RATING:	2.5	VIVIDNESS RATING:	+1.0
INTACTNESS	<p>Porter Avenue divides the vegetation along the background. The street trees and maintained lawn along Porter Avenue provides a continuous green strip from foreground to background. The intactness rating is moderately low.</p>		<p>The roundabout further divides the vegetation along the background by increasing pavement to the north and south. The street trees and maintained lawn along Porter Avenue provides a continuous green strip from foreground to background. The intactness rating is moderately low.</p>		<p>Intactness rating would slightly decrease.</p>	
	INTACTNESS RATING:	3.0	INTACTNESS RATING:	2.5	INTACTNESS RATING:	-0.5
UNITY	<p>The street trees and grass strips along Porter Avenue visually link the foreground and background. The continuous corridor of Porter Avenue provides supportive colors, textures and materials. The lawn areas are well maintained with little visual clutter from roadside signate and utilities. The unity rating is moderate/average.</p>		<p>The street trees and grass strips along Porter Avenue visually link the foreground and background. The continuous corridor of Porter Avenue provides supportive colors, textures and materials. The lawn areas are well maintained with little visual clutter from roadside signals and utilities. The unity rating is moderate/average.</p>		<p>Unity rating would not change.</p>

UNITY RATING:	4.0	UNITY RATING:	4.0	UNITY RATING:	0
TOTALS	Total of Existing Ratings (V+I+U)	8.5	Total of Proposed Ratings (V+I+U)	9.0	Total of Change Ratings (V+I+U)	+0.5
	Visual Quality (V+I+U)/3	2.8	Visual Quality (V+I+U)/3	3.0	Visual Quality (V+I+U)/3	+0.2

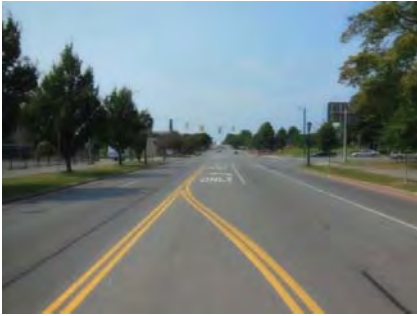
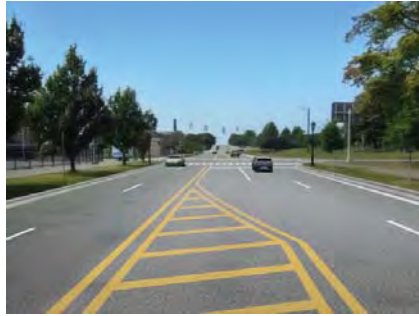
Visual Impact Assessment Worksheet						
Project:	New York Gateway Connections Improvement Project to the US Peace Bridge Plaza				Alternative:	Proposed Action
Location:	Porter Avenue Looking Southwest (Intersection Option)			Key View No.	1b	
Photos	Existing			Proposed

Viewer Group:	Local Residents / Travelers / Commuters / Recreational Users		Landscape Unit:	Commercial / Institutional	
	Existing		Proposed		Change	
VIVIDNESS	The foreground and middleground views are dominated by Porter Avenue, roadside landscaping, and commercial buildings are typical and unmemorable. The background view of Lake Erie is obstructed by the rising Porter Avenue that crosses the I-190. The vividness rating is low.		The foreground and middleground views are dominated by Porter Avenue, roadside landscaping, and commercial buildings are typical and unmemorable. The background view of Lake Erie remains obstructed by the intersection and rising Porter Avenue that crosses the I-190. The vividness rating is low.		Vividness rating would not change.

VIVIDNESS RATING:	1.5	VIVIDNESS RATING:	1.5	VIVIDNESS RATING:	0
INTACTNESS	Porter Avenue divides the vegetation along the background. The street trees and maintained lawn along Porter Avenue provides a continuous green strip from foreground to background. The intactness rating is moderately low.		Porter Avenue divides the vegetation along the background. The street trees and maintained lawn along Porter Avenue provides a continuous green strip from foreground to background. The intactness rating is moderately low.		Intactness rating would not change.	
	INTACTNESS RATING:	3.0	INTACTNESS RATING:	3.0	INTACTNESS RATING:	0
UNITY	The street trees and grass strips along Porter Avenue visually link the foreground and background. The continuous corridor of Porter Avenue provides supportive colors, textures and materials. The lawn areas are well maintained with little visual clutter from roadside signage and utilities. The unity rating is moderate/average.		The street trees and grass strips along Porter Avenue visually link the foreground and background. The continuous corridor of Porter Avenue provides supportive colors, textures and materials. The lawn areas are well maintained with little visual clutter from roadside signals and utilities. The unity rating is moderate/average.		Unity rating would not change.

UNITY RATING:	4.0	UNITY RATING:	4.0	UNITY RATING:	0
TOTALS	Total of Existing Ratings (V+I+U)	8.5	Total of Proposed Ratings (V+I+U)	8.5	Total of Change Ratings (V+I+U)	0
	Visual Quality (V+I+U)/3	2.8	Visual Quality (V+I+U)/3	2.8	Visual Quality (V+I+U)/3	0

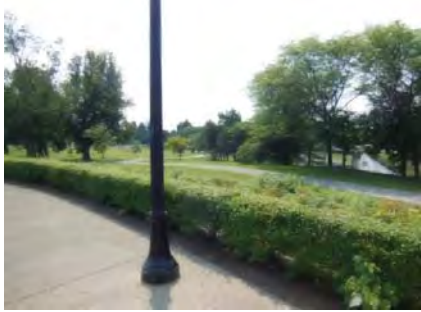
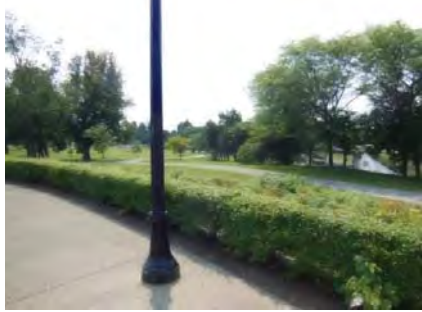
Visual Impact Assessment Worksheet							
Project:	New York Gateway Connections Improvement Project to the US Peace Bridge Plaza				Alternative:	Proposed Action	
Location:	Front Park Looking South				Key View No.	2	
Photos	Existing			Proposed

Viewer Group:		Recreational Users		Landscape Unit:		Recreation / Parkland
	Existing		Proposed		Change		
VIVIDNESS	The meandering multi-use trail presents an attractive sight in the middle/backgrounds. The well maintained landscaping and mature trees provide a striking viewshed which makes it memorable. The vividness rating is high.		The meandering multi-use trail presents an attractive sight in the middle/backgrounds. The well maintained landscaping and mature trees provide a striking viewshed which makes it memorable. The vividness rating is high.		Vividness rating would not change.		
	VIVIDNESS RATING:	5.5	VIVIDNESS RATING:	5.5	VIVIDNESS RATING:	0

INTACTNESS	The landscaping is intact except for the minor gap off to the right in the middleground. The landscaping is also contextually linked from the foreground to the background by the meandering multi-use trail. Minimal man-made features dot the landscape providing a more naturalized viewshed. The intactness rating is very high.		The landscaping is intact except for the minor gap off to the right in the middleground. The landscaping is also contextually linked from the foreground to the background by the meandering multi-use trail. Minimal man-made features dot the landscape providing a more naturalized viewshed. The intactness rating is very high.		Intactness rating would not change.		
	INTACTNESS RATING:	6.5	INTACTNESS RATING:	6.5	INTACTNESS RATING:	0	
UNITY	The lawn and landscaping are well maintained. The landscape palette of colors, textures and forms provides a harmonious natural viewshed. The absence of man-made features strengthens the natural forms of the landscape. The unity rating is very high.		The lawn and landscaping are well maintained. The landscape palette of colors, textures and forms provides a harmonious natural viewshed. The absence of man-made features strengthens the natural forms of the landscape. The unity rating is very high.		Unity rating would not change.

UNITY RATING:	6.5	UNITY RATING:	6.5	UNITY RATING:	0	
TOTALS	Total of Existing Ratings (V+I+U)	18.5	Total of Proposed Ratings (V+I+U)	18.5	Total of Change Ratings (V+I+U)	0	
	Visual Quality (V+I+U)/3	6.2	Visual Quality (V+I+U)/3	6.2	Visual Quality (V+I+U)/3	0

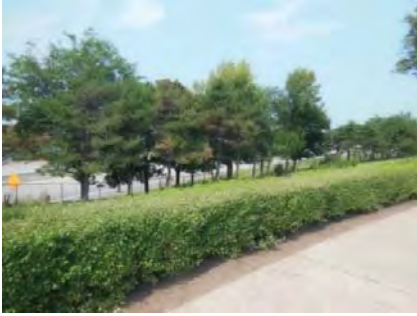
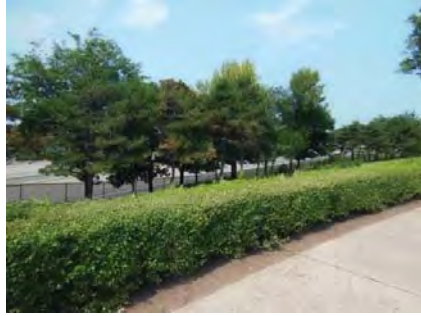
Visual Impact Assessment Worksheet						
Project:	New York Gateway Connections Improvement Project to the US Peace Bridge Plaza				Alternative:	Proposed Action
Location:	Front Park Looking Northwest			Key View No.	3	
Photos	Existing			Proposed

Viewer Group:		Recreational Users		Landscape Unit:		Recreation / Parkland
	Existing		Proposed		Change	
VIVIDNESS	The view is dominated by the mass of evergreens in the middleground and manicured hedge in the foreground. These elements are typical and provide little to the visual distinctiveness of the landscape which makes it unmemorable. The vividness rating is moderate/average.		The view is dominated by the mass of evergreens in the middleground and manicured hedge in the foreground. These elements are typical and provide little to the visual distinctiveness of the landscape which makes it unmemorable. The vividness rating is moderate/average.		Vividness rating would not change.

VIVIDNESS RATING:	4.0	VIVIDNESS RATING:	4.0	VIVIDNESS RATING:	0
INTACTNESS	While the landscaping is intact the man-made features of Ramp A and the chain-link fence subtract from the natural environment. The visual integrity is provided by the longitudinal patterns of the hedge, evergreen trees and Ramp A. The intactness rating is moderate/average.		While the landscaping is intact, the man-made features of Ramp A, including the widening, and the chain-link fence subtract from the natural environment. The visual integrity is provided by the longitudinal patterns of the hedge, evergreen trees and Ramp A. The intactness rating is moderate/average.		Intactness rating would not change.	
	INTACTNESS RATING:	3.5	INTACTNESS RATING:	3.5	INTACTNESS RATING:	0
UNITY	The forms of the hedge, evergreens and Ramp A combine to form a cohesive visual pattern between the man-made and natural features. However, the mass of evergreens obscures the background that subtracts from overall unity of the viewshed. The unity rating is moderately high.		The forms of the hedge, evergreens and Ramp A combine to form a cohesive visual pattern between the man-made and natural features. However, the mass of evergreens obscures the background that subtracts from overall unity of the viewshed. The unity rating is moderately high.		Unity rating would not change.

UNITY RATING:	4.5	UNITY RATING:	4.5	UNITY RATING:	0
TOTALS	Total of Existing Ratings (V+I+U)	12.0	Total of Proposed Ratings (V+I+U)	12.0	Total of Change Ratings (V+I+U)	0
	Visual Quality (V+I+U)/3	4.0	Visual Quality (V+I+U)/3	4.0	Visual Quality (V+I+U)/3	0

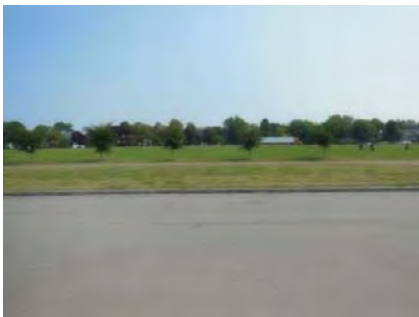
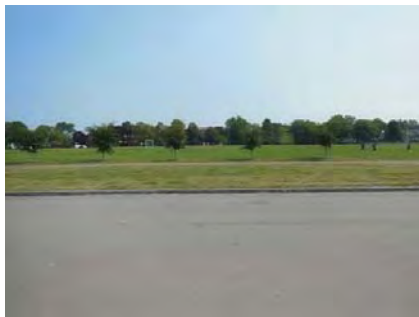
Visual Impact Assessment Worksheet						
Project:	New York Gateway Connections Improvement Project to the US Peace Bridge Plaza				Alternative:	Proposed Action
Location:	Front Park Looking East			Key View No.	4	
Photos	Existing			Proposed

Viewer Group:	Recreational Users		Landscape Unit:	Recreation / Parkland	
	Existing		Proposed		Change	
VIVIDNESS	<p>The view is dominated by the pavement of the terrace in the foreground and the open lawn of the middleground which contain no unique or memorable elements. The minor trees in the middleground and the landscaping off in the distance is typical and is not visually striking. The vividness rating is low.</p>		<p>The view is dominated by the pavement of the terrace in the foreground and the open lawn of the middleground which contain no unique or memorable elements. The minor trees in the middleground and the landscaping off in the distance is typical and is not visually striking. The vividness rating is low.</p>		<p>Vividness rating would not change.</p>

VIVIDNESS RATING:	1.5	VIVIDNESS RATING:	1.5	VIVIDNESS RATING:	0
INTACTNESS	<p>There is a strong visual order with the pavement in the foreground, open lawn in the middleground and the landscaping in the background. The minor trees and Plaza access does little to subtract from this order. Minimal man-made features dot the landscape providing a more naturalized viewshed. The intactness rating is high.</p>		<p>There is a strong visual order with the pavement in the foreground, open lawn in the middleground and the landscaping in the background. The minor trees do little to subtract from this order, while the removal of man-made features, including Baird Drive, strengthens the open lawn area. The intactness rating is high.</p>		<p>Intactness rating would slightly increase.</p>	
	INTACTNESS RATING:	6.0	INTACTNESS RATING:	6.5	INTACTNESS RATING:	+0.5
UNITY	<p>The linear forms of the pavement, open lawn and landscaping in the background create a cohesive visual pattern between the man-made and natural features. However, the contrasting colors and textures between the pavement and landscaping provides no integration of the man-made development with the natural setting. The unity rating is moderate/average.</p>		<p>The linear forms of the pavement, open lawn and landscaping in the background create a cohesive visual pattern between the man-made and natural features. However, the contrasting colors and textures between the pavement and landscaping provides no integration of the man-made development with the natural setting. The unity rating is moderate/average.</p>		<p>Unity rating would not change.</p>

UNITY RATING:	4.0	UNITY RATING:	4.0	UNITY RATING:	0
TOTALS	Total of Existing Ratings (V+I+U)	11.5	Total of Proposed Ratings (V+I+U)	12.0	Total of Change Ratings (V+I+U)	+0.5
	Visual Quality (V+I+U)/3	3.8	Visual Quality (V+I+U)/3	4.0	Visual Quality (V+I+U)/3	+0.2

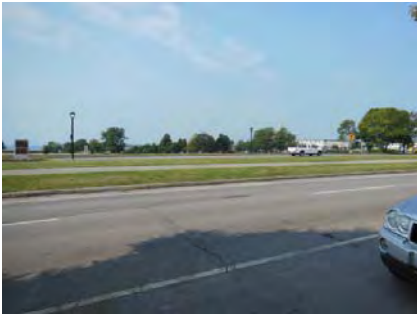
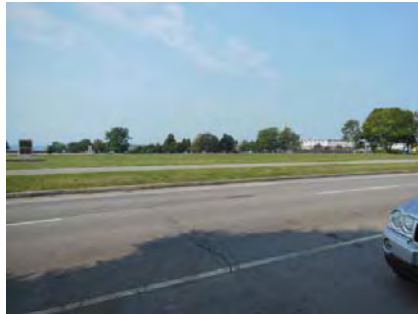
Visual Impact Assessment Worksheet						
Project:	New York Gateway Connections Improvement Project to the US Peace Bridge Plaza				Alternative:	Proposed Action
Location:	Busti Avenue Looking West				Key View No.	5
Photos	Existing		Proposed

Viewer Group:	Local Residents		Landscape Unit:	Urban Residential	
	Existing		Proposed		Change	
VIVIDNESS	The view is dominated by Busti Avenue and the park's open lawn which contain no unique or memorable elements. The striking view of Lake Erie is obscured by the vegetation and plaza subtracting from the water's relation to the landscape. The vividness rating is low.		The view is dominated by Busti Avenue and the park's open lawn which contain no unique or memorable elements. The striking view of Lake Erie is obscured by the vegetation and plaza subtracting from the water's relation to the landscape. The vividness rating is low.		Vividness rating would not change.

VIVIDNESS RATING:	2.0	VIVIDNESS RATING:	2.0	VIVIDNESS RATING:	0
INTACTNESS	There is a strong visual order with the pavement in the foreground, open lawn in the middleground and the landscaping in the background. The minor trees and plaza access does little to subtract from this order. Few man-made features dot the landscape providing a more naturalized viewshed. The intactness rating is moderately high.		There is a strong visual order with the pavement in the foreground, open lawn in the middleground and the landscaping in the background. The minor trees do little to subtract from this order, while the removal of man-made features, including Baird Drive, strengthens the open lawn area. Few man-made features dot the landscape providing a more naturalized viewshed. The intactness rating is high.		Intactness rating would slightly increase.	
	INTACTNESS RATING:	5.0	INTACTNESS RATING:	5.5	INTACTNESS RATING:	+0.5

UNITY	The linear forms of the pavement, open lawn and landscaping in the background create a cohesive visual pattern between the man-made and natural features. The contrasting colors and textures between the pavement and landscaping provides no integration of the man-made development with the natural setting. There is no strong connection to the water. The unity rating is moderately low.		The linear forms of the pavement, open lawn and landscaping in the background create a cohesive visual pattern between the man-made and natural features. The contrasting colors and textures between the pavement and landscaping provides no integration of the man-made development with the natural setting. There is no strong connection to the water. The unity rating is moderate/average.		Unity rating would slightly increase.	
	UNITY RATING:	3.5	UNITY RATING:	4.0	UNITY RATING:	+0.5
TOTALS	Total of Existing Ratings (V+I+U)	10.5	Total of Proposed Ratings (V+I+U)	11.5	Total of Change Ratings (V+I+U)	1.0

Visual Quality (V+I+U)/3	3.5	Visual Quality (V+I+U)/3	3.8	Visual Quality (V+I+U)/3	0.3

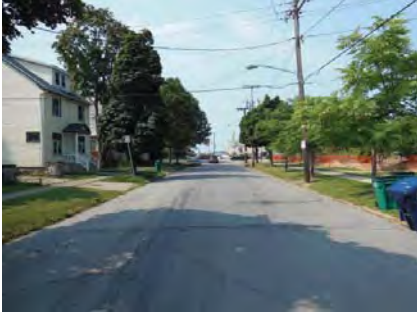
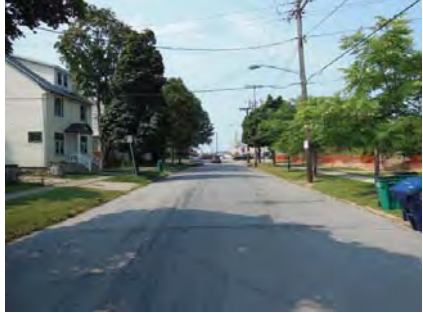
Visual Impact Assessment Worksheet							
Project:	New York Gateway Connections Improvement Project to the US Peace Bridge Plaza				Alternative:	Proposed Action	
Location:	Vermont Street Looking Southwest				Key View No.	6	
Photos	Existing			Proposed

Viewer Group:	Local Residents / Business Employees		Landscape Unit:	Urban Residential		
	Existing		Proposed		Change		
VIVIDNESS	The lining of street trees manipulate the view focusing on the plaza's gated entrance and facility which is not unique or memorable. Man-made elements are scattered throughout the view providing too many contrasting elements. The vividness rating is low.		The lining of street trees manipulate the view focusing on the Plaza's gated entrance and facility which is not unique or memorable. Man-made elements are scattered throughout the view providing too many contrasting elements. The vividness rating is low.		Vividness rating would not change.

VIVIDNESS RATING:	1.5	VIVIDNESS RATING:	1.5	VIVIDNESS RATING:	0	
INTACTNESS	The two story residences with the street trees present a fairly intact view of an urban residential street. The varying architectural styles, materials, colors and textures is typical for this type of neighborhood. Utility poles and overhead wires encroach on the residential street image. The intactness rating is low.		The two story residences with the street trees present a fairly intact view of an urban residential street. The varying architectural styles, materials, colors and textures is typical for this type of neighborhood. Utility poles and overhead wires encroach on the residential street image. The intactness rating is low.		Intactness rating would not change.		
	INTACTNESS RATING:	2.5	INTACTNESS RATING:	2.5	INTACTNESS RATING:	0	
UNITY	Street details, including pavement, sidewalks, planting area and lawn, are well defined and maintained. The utility poles and overhead wires degrade the overall harmony of the view. The unity rating is low.		Street details, including pavement, sidewalks, planting area and lawn, are well defined and maintained. The utility poles and overhead wires degrade the overall harmony of the view. The unity rating is low.		Unity rating would not change.

UNITY RATING:	2.5	UNITY RATING:	2.5	UNITY RATING:	0	
TOTALS	Total of Existing Ratings (V+I+U)	6.5	Total of Proposed Ratings (V+I+U)	6.5	Total of Change Ratings (V+I+U)	0	
	Visual Quality (V+I+U)/3	2.2	Visual Quality (V+I+U)/3	2.2	Visual Quality (V+I+U)/3	0

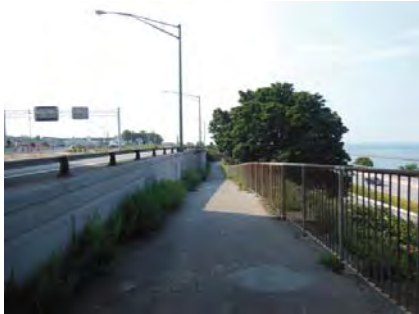
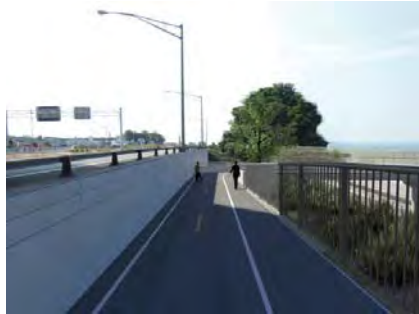
Visual Impact Assessment Worksheet						
Project:	New York Gateway Connections Improvement Project to the US Peace Bridge Plaza				Alternative:	Proposed Action
Location:	Shoreline Trail Looking South				Key View No.	7
Photos	Existing			Proposed

Viewer Group:	Local Residents / Business Employees / Travelers / Commuters		Landscape Unit:	Transportation Corridors	
	Existing		Proposed		Change	
VIVIDNESS	The open view of Lake Erie provides a unique element and draws the attention away from the roadway's elements. The vegetation and water provides some color and texture to the viewshed. The vividness rating is high.		The elimination of the open view of Lake Erie reduces this unique element and refocuses on the roadway structural and utility elments making this view unmemorable. The vegetation and water provides some color and texture to the viewshed. The vividness rating is moderate/average.		Vividness rating would decrease.

VIVIDNESS RATING:	5.5	VIVIDNESS RATING:	3.5	VIVIDNESS RATING:	-2.0
INTACTNESS	The vegetation along the Shoreline Trail obscures the visual connection to the distant water of Lake Erie, and the roadway's pavement and water present conflicting landscape characters. The lack of maintenance along the Shoreline Trail degrades the visual integrity of the landscape. The intactness rating is moderately low.		The vegetation and pedestrian bridge obscures the visual connection to the distant water of Lake Erie, and the roadway's pavement and water present conflicting landscape characters. Man-made elements are scattered throughout the view providing too many contrasting elements. The intactness rating is low.		Intactness rating would decrease.	
	INTACTNESS RATING:	3.5	INTACTNESS RATING:	2.0	INTACTNESS RATING:	-1.5
UNITY	The lack of a visual connection between the water and the roadways creates little harmony between the man-made and natural elements. The linear wall and the vegetation screen do little to integrate the man-made features with the landscape. The unity rating is moderately low.		The lack of a visual connection between the water and the roadways creates little harmony between the man-made and natural elements. The linear wall and the vegetation screen do little to integrate the man-made features with the landscape. The unity rating is moderately low.		Unity rating would not change.

UNITY RATING:	2.5	UNITY RATING:	2.5	UNITY RATING:	0
TOTALS	Total of Existing Ratings (V+I+U)	11.5	Total of Proposed Ratings (V+I+U)	8.0	Total of Change Ratings (V+I+U)	-3.5
	Visual Quality (V+I+U)/3	3.8	Visual Quality (V+I+U)/3	2.7	Visual Quality (V+I+U)/3	-1.2

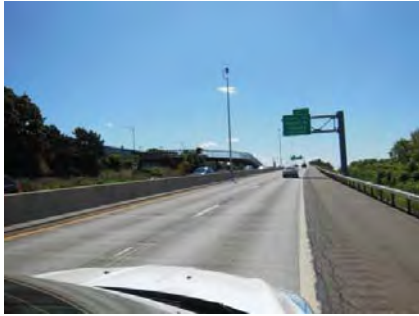
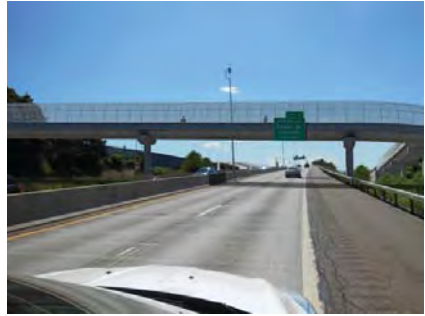
Visual Impact Assessment Worksheet							
Project:	New York Gateway Connections Improvement Project to the US Peace Bridge Plaza				Alternative:	Proposed Action	
Location:	Southbound I-190 Looking South				Key View No.	8	
Photos	Existing			Proposed

Viewer Group:	Business Employees / Travelers / Commuters		Landscape Unit:	Transportation Corridors		
	Existing		Proposed		Change		
VIVIDNESS	The highway pavement with vegetation to the east and west is not unusual making this view unmemorable. Man-made elements are scattered throughout the view providing too many contrasting elements. The vividness rating is low.		The view of the pedestrian bridge crossing the viewshed provides a unique element within a typical highway viewshed. Man-made elements are scattered throughout the view providing too many contrasting elements. The vividness rating is moderate/average.		Vividness rating would increase.

VIVIDNESS RATING:	2.5	VIVIDNESS RATING:	3.5	VIVIDNESS RATING:	+1.0	
INTACTNESS	The trees and shrubs along the east partially screen views of Ramp S and the pedestrian bridge. However, the highway disrupts the connection between the natural setting to the west and the one to the east, thus creating conflicting landscape characters. The intactness rating is low.		The pedestrian bridge and highway disrupt the connection between the natural settings on the east and west, with the bridge almost eliminating the vegetation on the west. The intactness rating is low.		Intactness rating would decrease.		
	INTACTNESS RATING:	2.5	INTACTNESS RATING:	1.5	INTACTNESS RATING:	-1.0	
UNITY	Minimal vegetation with the highway in the middle degrades the natural setting creating little harmony between the man-made and natural elements. The vegetation and highway's contrasting colors and textures provide little integration of the man-made elements with its surrounding landscape. The unity rating is moderately low.		The various highway features and minimal vegetation provides little harmony between the man-made features and the natural elements. However, the similar color and simple textures of the pedestrian bridge provides some unity within the man-made features. The unity rating is moderately low.		Unity rating would increase.

UNITY RATING:	2.5	UNITY RATING:	3.5	UNITY RATING:	+1.0	
TOTALS	Total of Existing Ratings (V+I+U)	7.5	Total of Proposed Ratings (V+I+U)	8.5	Total of Change Ratings (V+I+U)	+1.0	
	Visual Quality (V+I+U)/3	2.5	Visual Quality (V+I+U)/3	2.8	Visual Quality (V+I+U)/3	+0.3

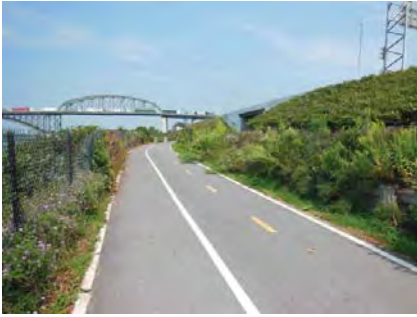
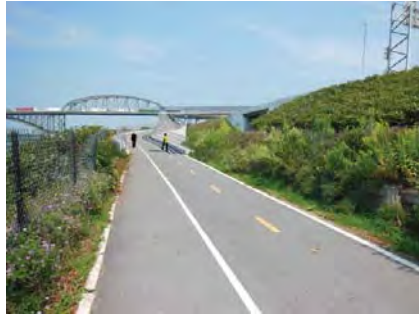
Visual Impact Assessment Worksheet						
Project:	New York Gateway Connections Improvement Project to the US Peace Bridge Plaza				Alternative:	Proposed Action
Location:	Shoreline Trail Looking North			Key View No.	9	
Photos	Existing			Proposed

Viewer Group:		Recreational Users		Landscape Unit:		River / Waterfront
	Existing		Proposed		Change	
VIVIDNESS	The view along the Shoreline Trail presents an attractive view of the Peace Bridge in the distance. In addition, the overgrown vegetation in the foreground and middleground provides varying texture and color making the view memorable. The vividness rating is high.		The view along the Shoreline Trail presents an attractive view of the Peace Bridge in the distance. The introduction of the pedestrian bridge and ramp reduces the overall impact from the varying texture and color from the overgrown vegetation in the foreground and middleground. The vividness rating is high.		Vividness rating slightly decrease.

VIVIDNESS RATING:	6.5	VIVIDNESS RATING:	6.0	VIVIDNESS RATING:	-0.5
INTACTNESS	The Peace Bridge structure encroaches on the mainly natural landscape within the viewshed drawing ones focus away from the landscape and onto the man-made structure. The chain-link fence within the vegetation competes with the natural form, colors and texture of the landscape. The intactness rating is low.		The Peace Bridge structure and the pedestrian bridge and ramp encroaches on the mainly natural landscape within the viewshed drawing ones focus away from the landscape and onto the man-made structures. The chain-link fence within the vegetation competes with the natural form, colors and texture of the landscape. The intactness rating is low.		Intactness rating decrease.	
	INTACTNESS RATING:	2.5	INTACTNESS RATING:	1.5	INTACTNESS RATING:	-1.0
UNITY	Except for the bridge in the background, the natural vegetation blends with the man-made structures of the I-190 underpass and chain-link fence. The curve at the end of the Shoreline Trail ties the man-made structure with the surrounding landscape creating a unity between the natural and man-made elements. The unity rating is moderately high.		The pedestrian bridge and ramp plus the Peace Bridge in the background, reduces the unity between the natural vegetation and man-made structures. The Shoreline Trail's ramp disrupts the natural vegetation along the shoreline, reducing the overall unity of the natural landscape. The unity rating is moderately low.		Unity rating would decrease.

UNITY RATING:	4.5	UNITY RATING:	2.5	UNITY RATING:	-2.0
TOTALS	Total of Existing Ratings (V+I+U)	13.5	Total of Proposed Ratings (V+I+U)	10.0	Total of Change Ratings (V+I+U)	-3.5
	Visual Quality (V+I+U)/3	4.5	Visual Quality (V+I+U)/3	3.3	Visual Quality (V+I+U)/3	-1.2

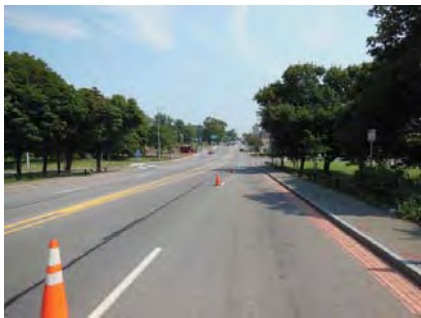
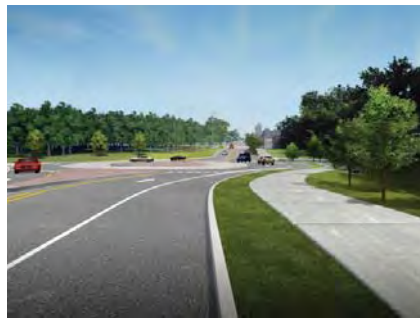
Visual Impact Assessment Worksheet						
Project:	New York Gateway Connections Improvement Project to the US Peace Bridge Plaza				Alternative:	Proposed Action
Location:	Porter Avenue Looking Northeast (Roundabout Option)			Key View No.	10a	
Photos	Existing			Proposed

Viewer Group:	Local Residents / Business Employees / Travelers / Commuters / Recreational Users		Landscape Unit:	Transportation Corridors	
	Existing		Proposed		Change	
VIVIDNESS	<p>The foreground and middleground views are dominated by Porter Avenue and roadside elements, including street trees, which are typical and unmemorable. The commercial buildings in the background are partially obscured by the vegetation. The vividness rating is low.</p>		<p>The foreground and middleground views are dominated by the roundabout, which is a unique element within the viewshed. The lack of a focal element within the roundabout provides a more typical streetscape and is unmemorable. The commercial buildings in the background are partially obscured by the vegetation. The vividness rating is moderate/average.</p>		<p>Vividness rating would increase.</p>

VIVIDNESS RATING:	2.5	VIVIDNESS RATING:	3.5	VIVIDNESS RATING:	+1.0
INTACTNESS	<p>Porter Avenue and its street trees provides visual continuity from foreground to the background. Porter Avenue's roadside elements, such as the brick edging, sidewalks, street trees and maintained lawn areas provide visual order. The intactness rating is moderate/average.</p>		<p>The roundabout disrupts Porter Avenue and its street trees reducing the visual continuity from foreground to background. However, the roadside elements, such as sidewalks, street trees and maintained lawn areas provide visual order. The intactness rating is moderate/average.</p>		<p>Intactness rating would slightly decrease.</p>	
	INTACTNESS RATING:	4.0	INTACTNESS RATING:	3.5	INTACTNESS RATING:	-0.5
UNITY	<p>The colors, textures and patterns of the roadside elements unify the man-made elements. The addition of the natural landscape creates a coherent visual pattern. The unity rating is moderately high.</p>		<p>The colors, textures and patterns of the roadside elements unify the man-made elements. The addition of the natural landscape creates a coherent visual pattern. The unity rating is moderately high.</p>		<p>Unity rating would not change.</p>

UNITY RATING:	5.0	UNITY RATING:	5.0	UNITY RATING:	0
TOTALS	Total of Existing Ratings (V+I+U)	11.5	Total of Proposed Ratings (V+I+U)	12.0	Total of Change Ratings (V+I+U)	+0.5
	Visual Quality (V+I+U)/3	3.8	Visual Quality (V+I+U)/3	4.0	Visual Quality (V+I+U)/3	+0.2

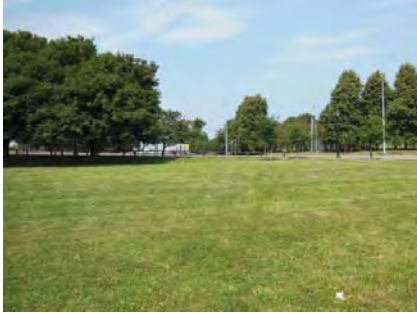
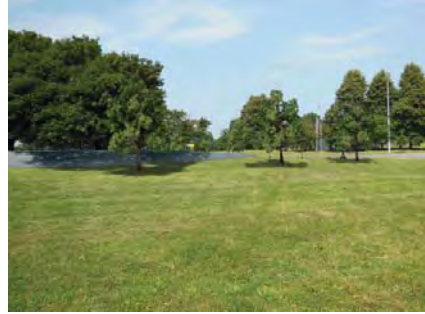
Visual Impact Assessment Worksheet							
Project:	New York Gateway Connections Improvement Project to the US Peace Bridge Plaza				Alternative:	Proposed Action	
Location:	D'Youville College Athletic Fields Looking North				Key View No.	11	
Photos	Existing			Proposed

Viewer Group:	Local Residents / Recreational Users		Landscape Unit:	Transportation Corridors		
	Existing		Proposed		Change		
VIVIDNESS	The open lawn in the foreground dominates the view and does not contain any unique or memorable elements. Porter Avenue in the middleground, with its utility and streetscape elements are typical and unmemorable. The vividness rating is low.		The open lawn in the foreground dominates the view and does not contain any unique or memorable elements. The Porter Avenue roundabout in the middleground, with its utility and streetscape elements, are typical and unmemorable. The vividness rating is low.		Vividness rating would not change.

VIVIDNESS RATING:	2.5	VIVIDNESS RATING:	2.5	VIVIDNESS RATING:	0	
INTACTNESS	Except for Ramp P in the background, the wooded middleground and background is mainly intact. In addition, Porter Avenue does little to disrupt the visual relationship between the open lawn and wooded background. The utility and streetscape vertical elements partially disrupts the natural setting of the viewshed. The intactness rating is moderately high.		Except for roundabout's retaining wall in the middleground, the vegetation in the middleground and background is mainly intact. In addition, the roundabout does little to disrupt the visual relationship between the open lawn and wooded background. The utility and streetscape vertical elements partially disrupts the natural setting of the viewshed. The intactness rating is moderate/average.		Intactness rating would slightly decrease.		
	INTACTNESS RATING:	4.5	INTACTNESS RATING:	4.0	INTACTNESS RATING:	-0.5
